Deficiency Photo of the Year – 2023

Ship name:	MSC RESILIENT III
IMO Number:	9240873
Flag:	Liberia
Call sign/MMSI	D5UN9/636019443
Ship type:	Container ship
Date keel laid:	04.03.2002
Gross tonnage:	27,093
Recognized organization:	DNV AS
ISM Company:	MSC Shipmanagement Ltd (IMO No. 1535947)
Port of inspection:	Brisbane, QLD, Australia
Date of inspection:	08.02.2023
Detention:	Yes

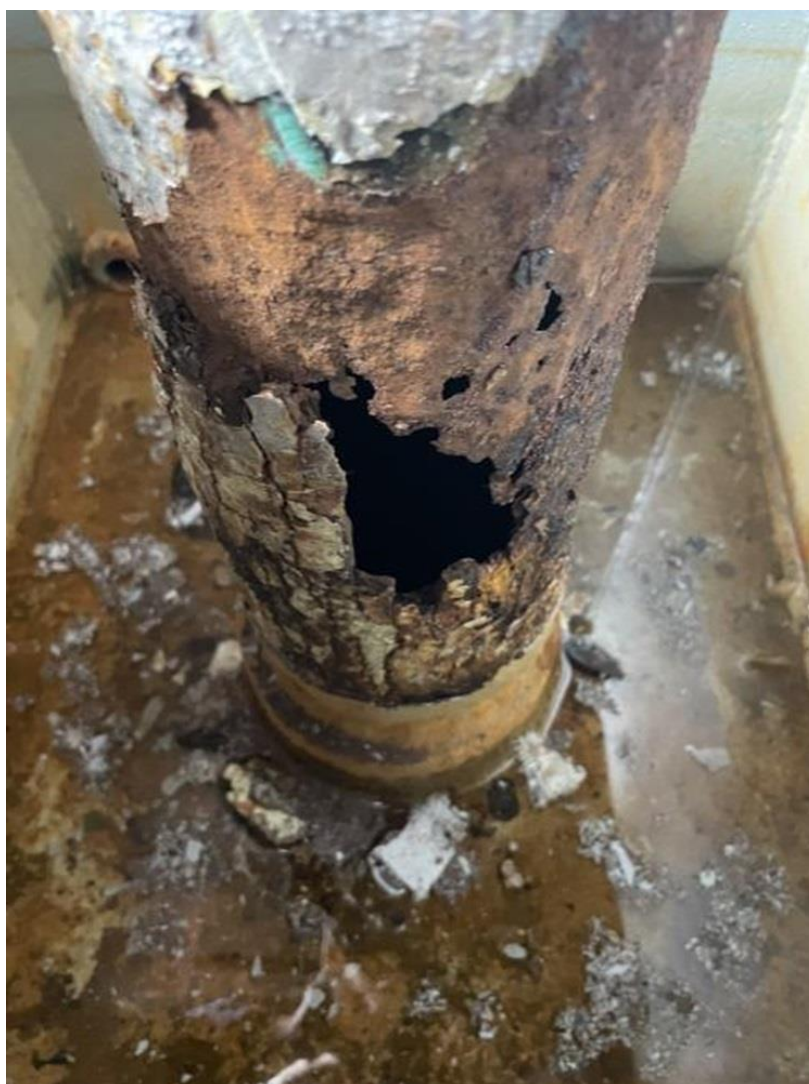
Nature of deficiency:	Ventilators, air pipes, casings: Air pipe of no. 3 HFO tank on starboard forward wasted and holed.
Reason for winning the prize:	This picture provides a close-up view of the seriously rusted air pipe.
Photo of detainable deficiency:	Yes

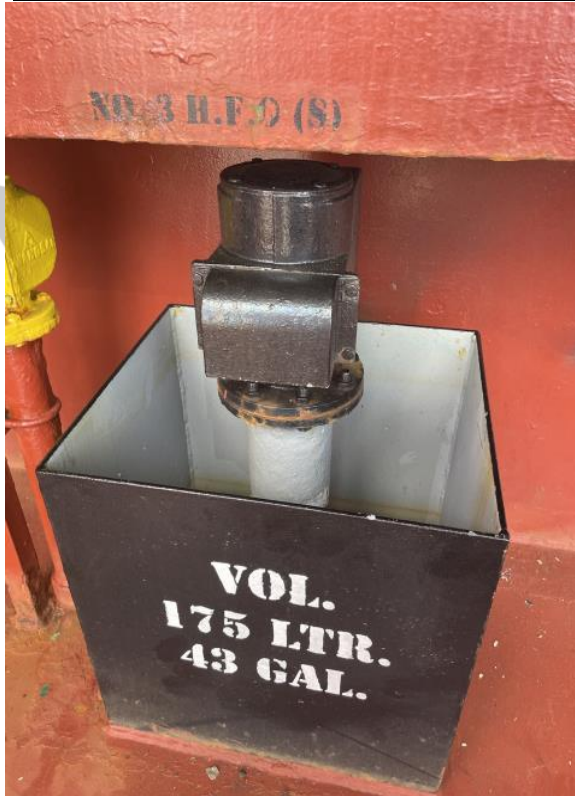
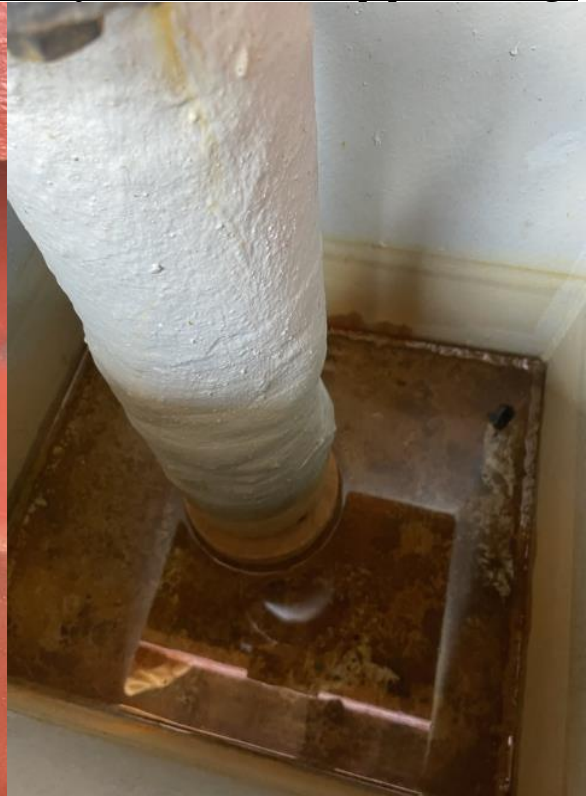
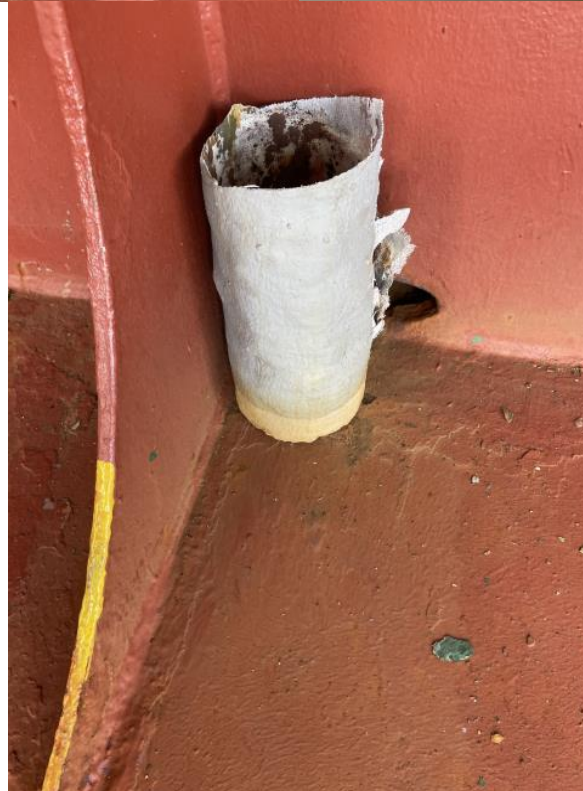
Pictures of the same detainable deficiency: Ventilators, air pipes, casings

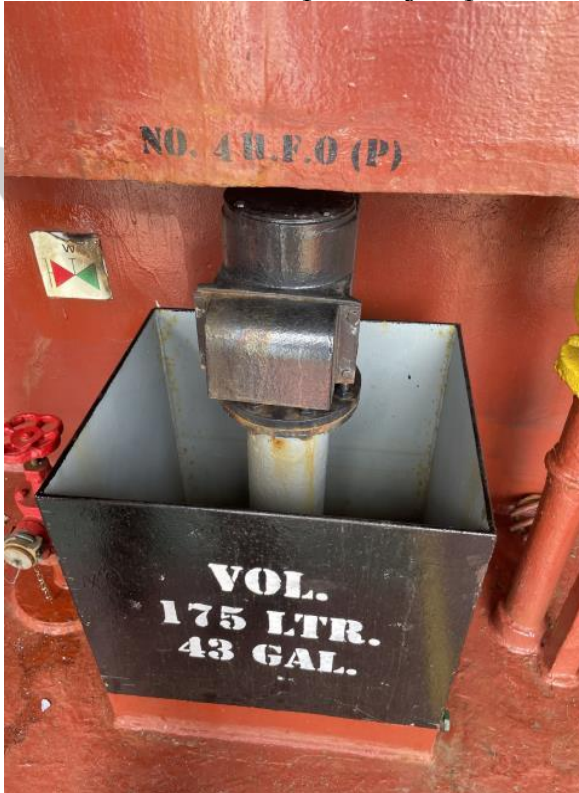
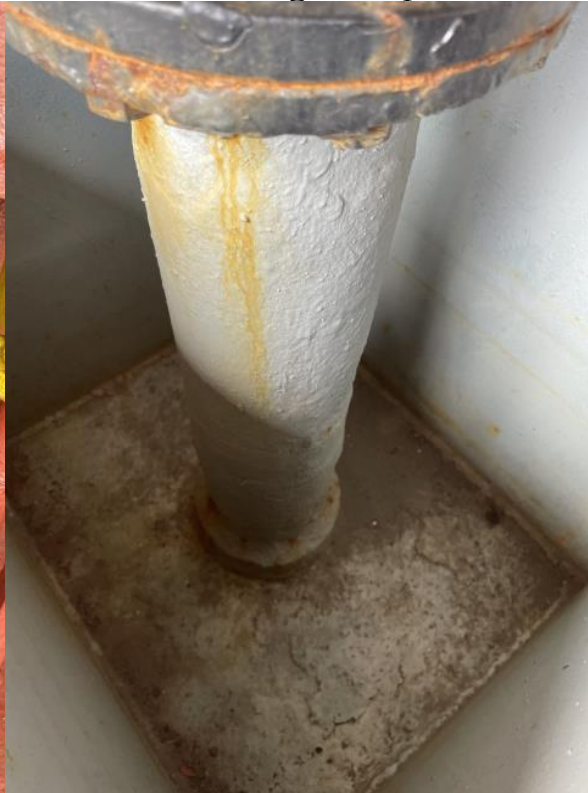
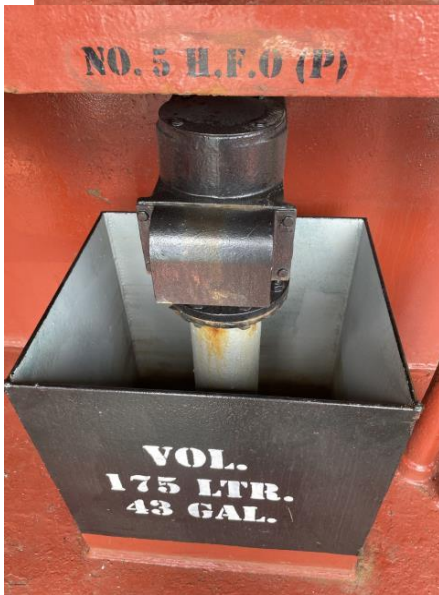
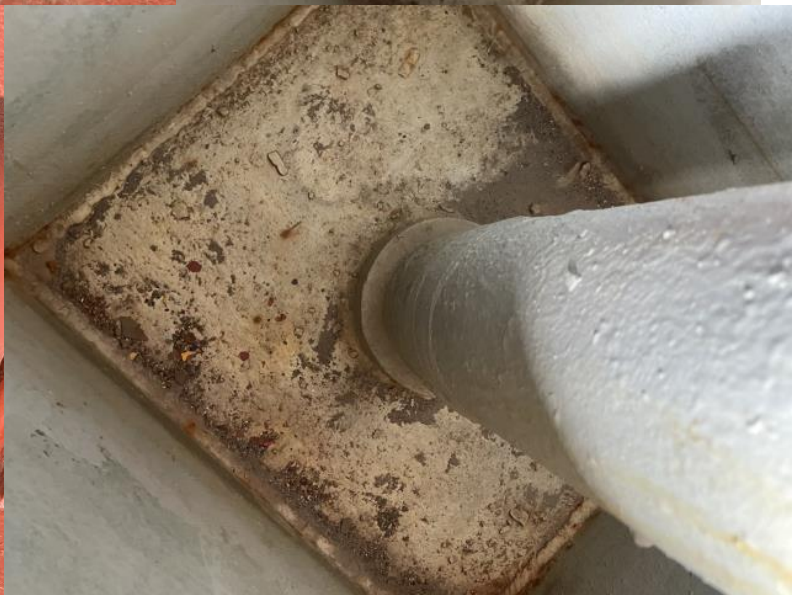
Pictures of other deficiency: Air pipe of HFO tank no. 4P forward and HFO no. 5P forward temporarily repaired with canvas bandage and painted.

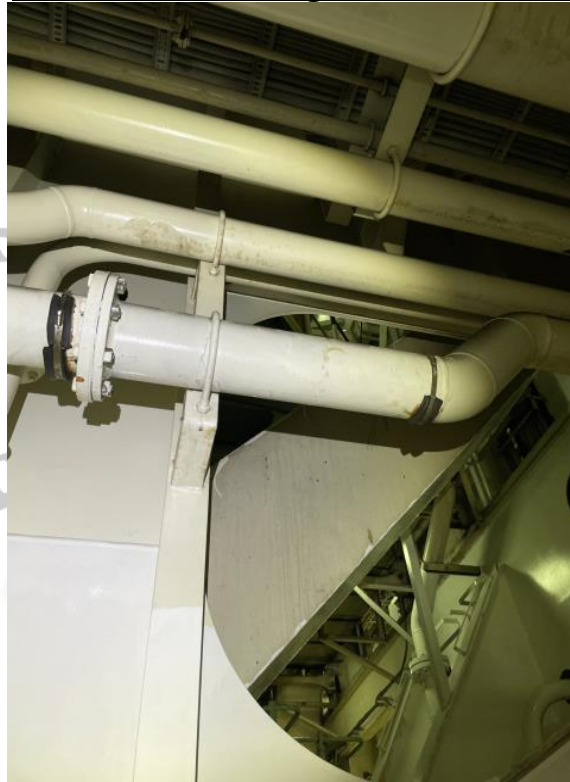
Picture of other deficiency: Grey water overboard line temporarily repaired with rubber bandage in 2 locations.

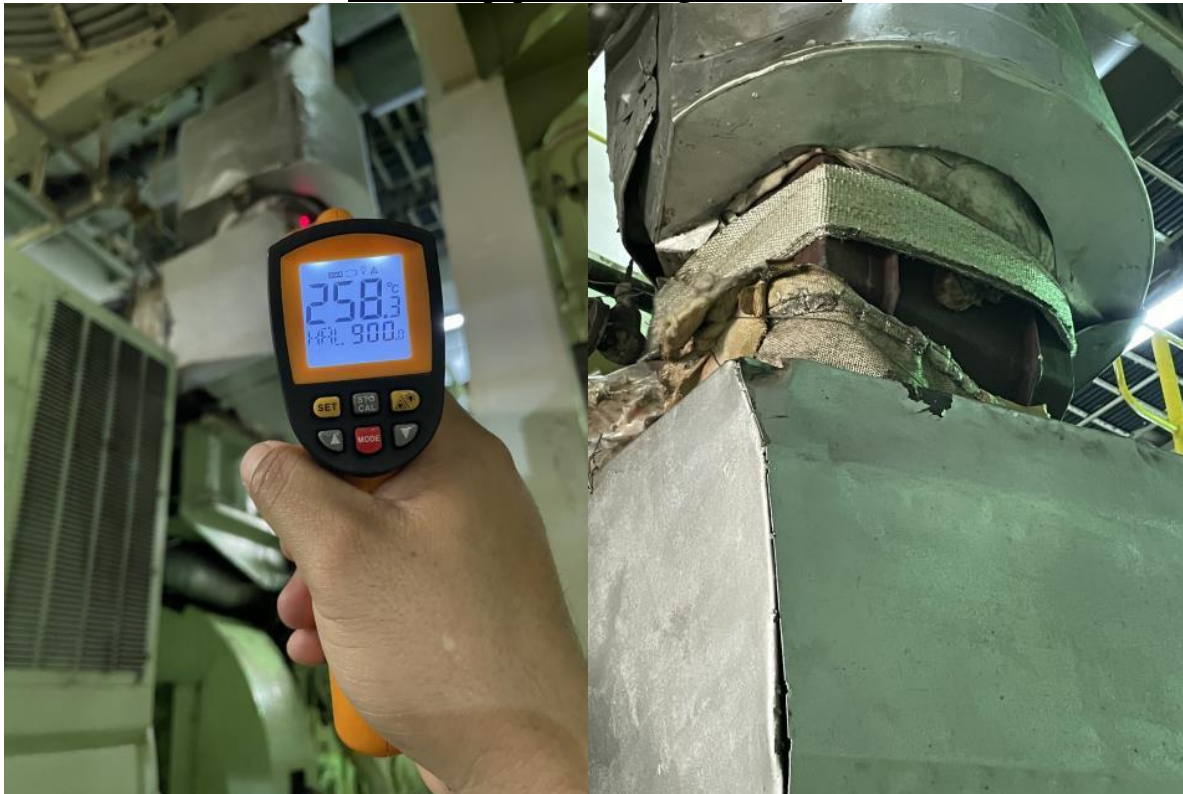
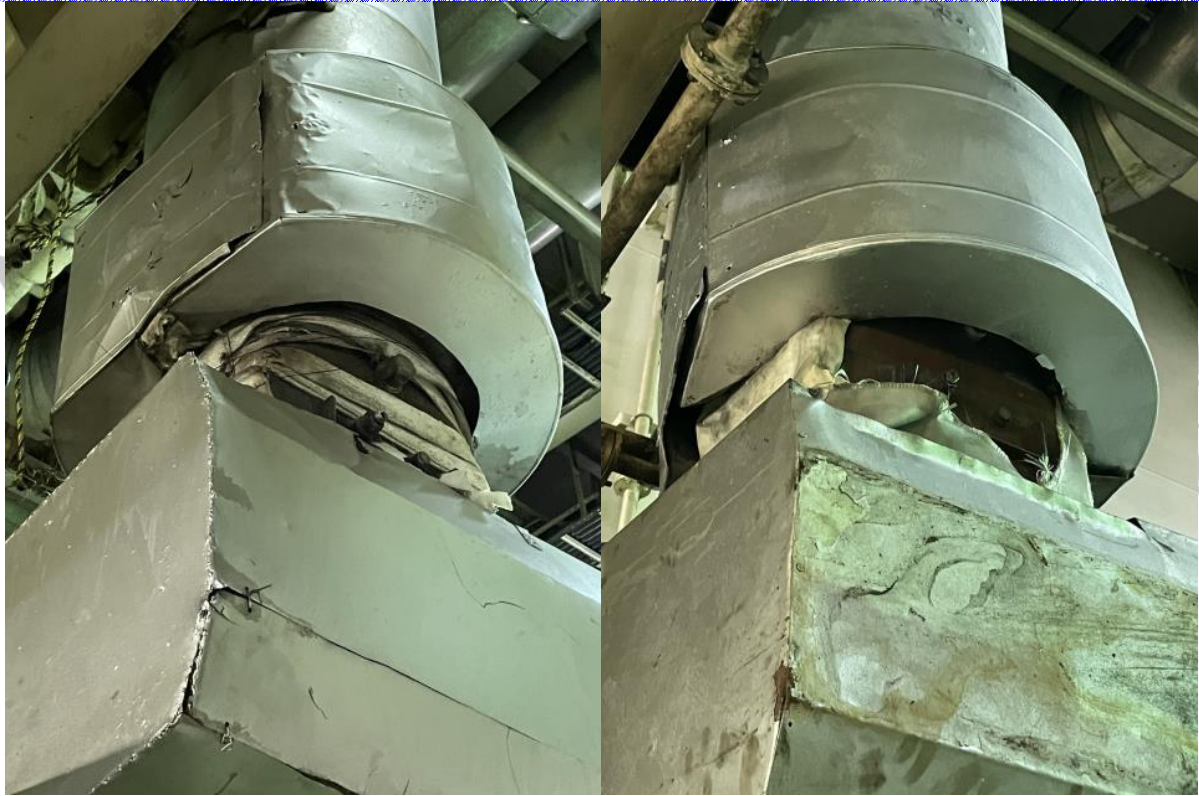
Pictures of other deficiency: Section of insulation missing on the turbocharger exhaust pipe of all 4 generators

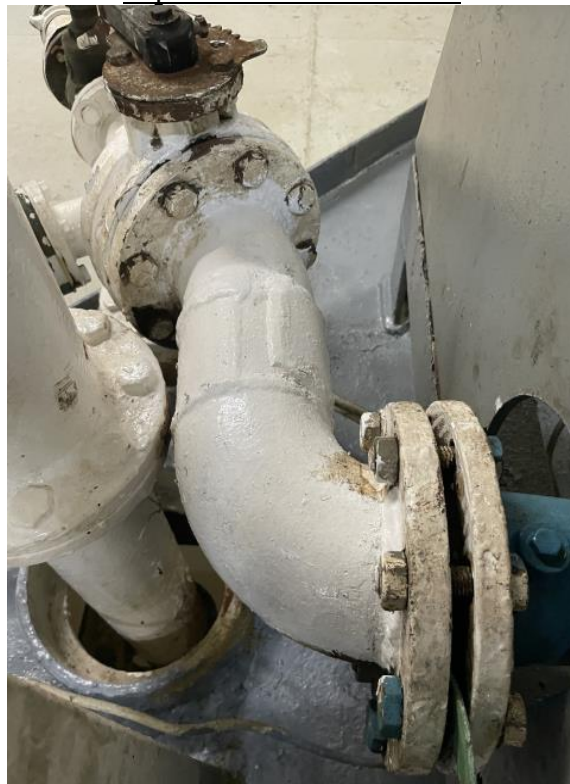
Picture of other deficiency: Fresh water generator outlet pipe temporarily repaired with doubler

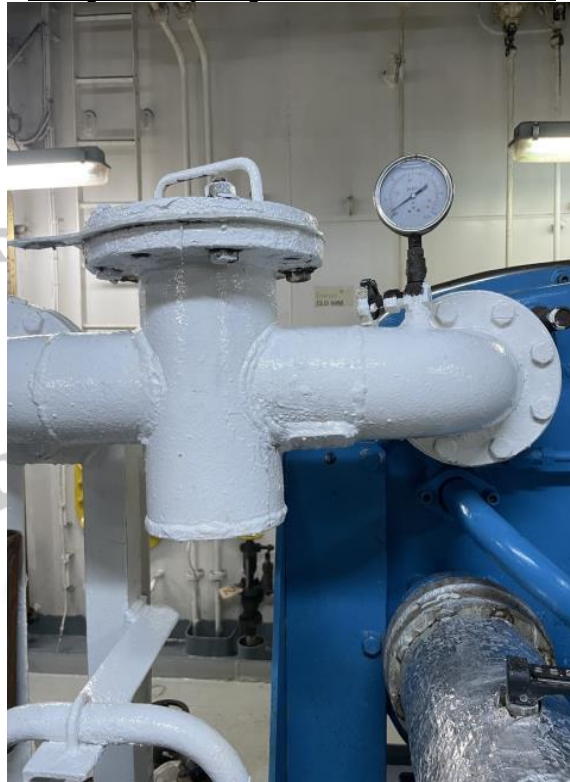
Picture of other deficiency: Fresh water generator seawater inlet pipe temporarily repaired with doubler

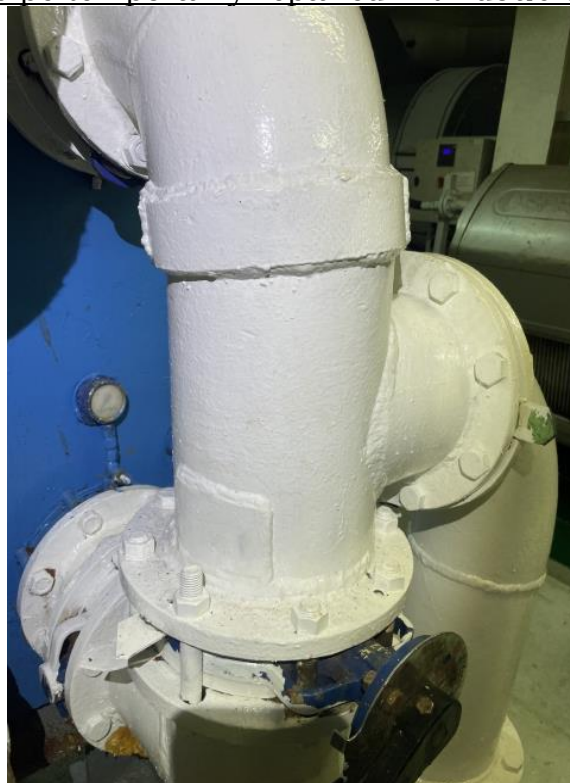
Picture of other deficiency: Main engine jacket water cooler seawater outlet pipe temporarily repaired with doubler

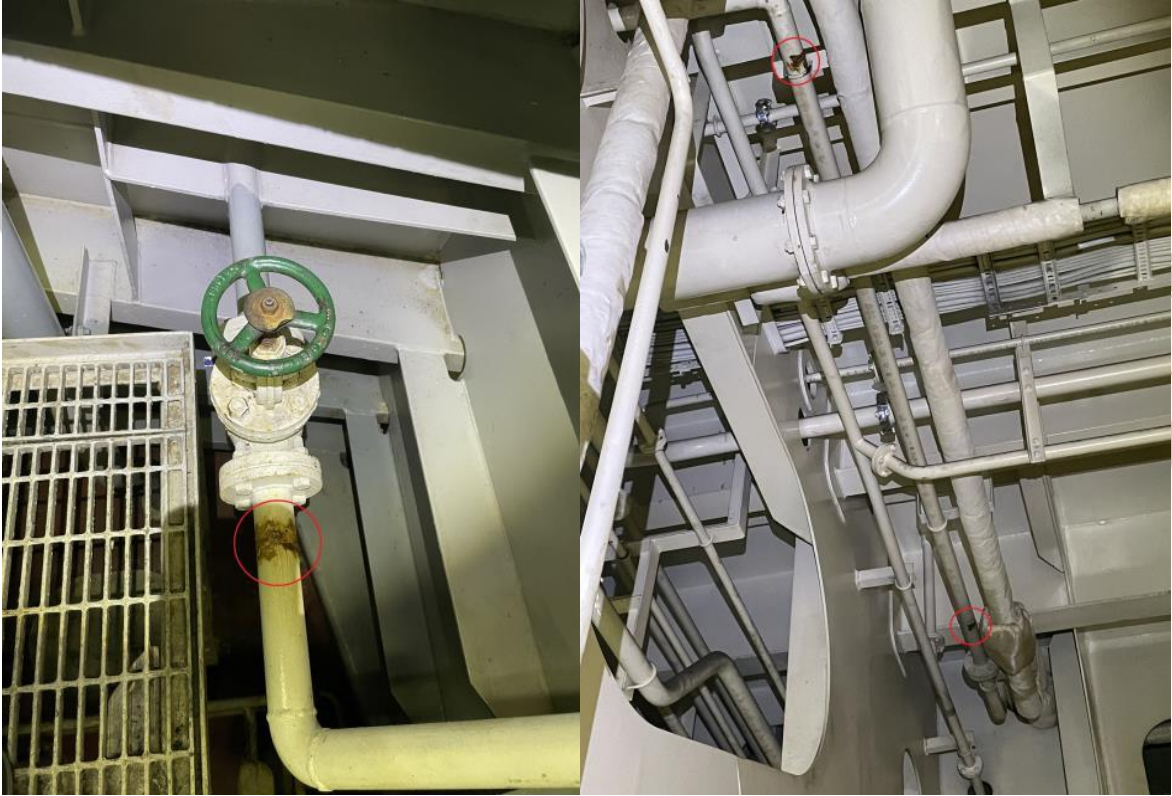
Pictures of other deficiency: Cooling seawater outlet for deck machinery found leaking in 3 locations
